Facility Name/City: Clean Harbors Kansas LLC, 2549 North New York Avenue, Wichita, Kansas 67219

Date: October 17-18, 2012

CLEAN HARBORS KANSAS LLC
2549 North New York Avenue
Wichita, Kansas 67219
KSD007246846

RCRA CEI Photos

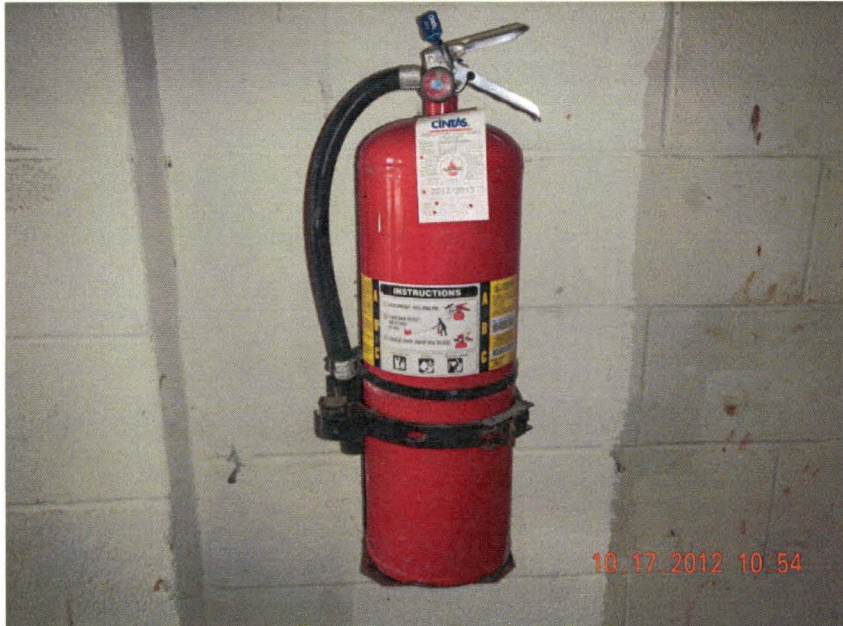
Photo 1

Photo of one fire extinguisher (1 of 3 with no marked inspection date) located at Building I. Photo taken facing east.

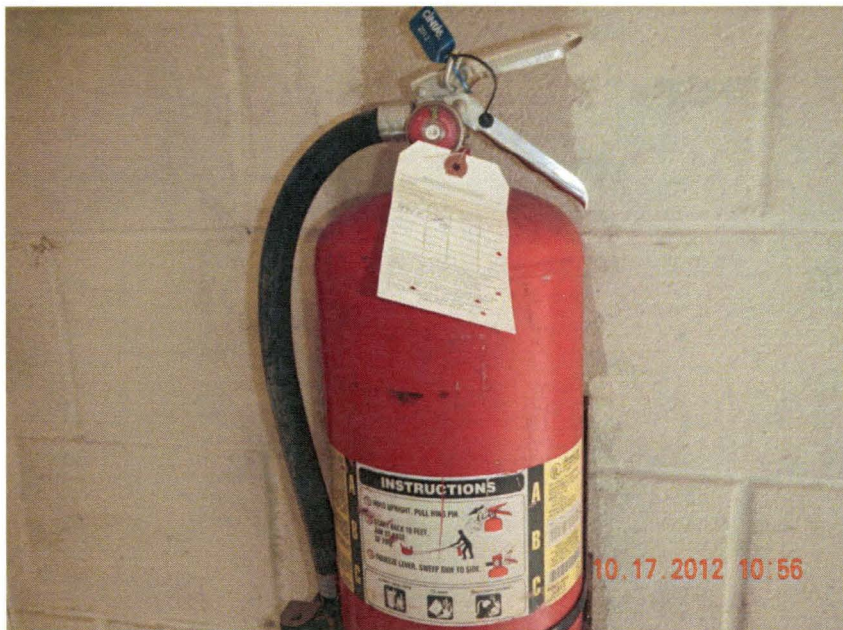
Photo 2

Photo of one fire extinguisher (1 of 4 with the April 30, 2012 last inspection date) located at Building I. Photo taken facing south.

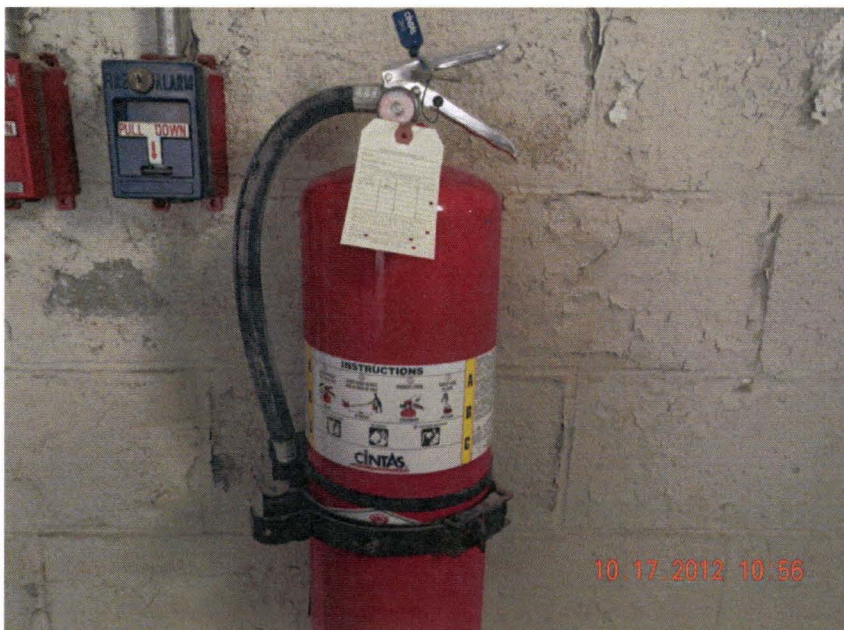
Photo 4

Photo of one fire extinguisher (2 of 4 with the April 30, 2012 last inspection date) located at Building I. Photo taken facing east.

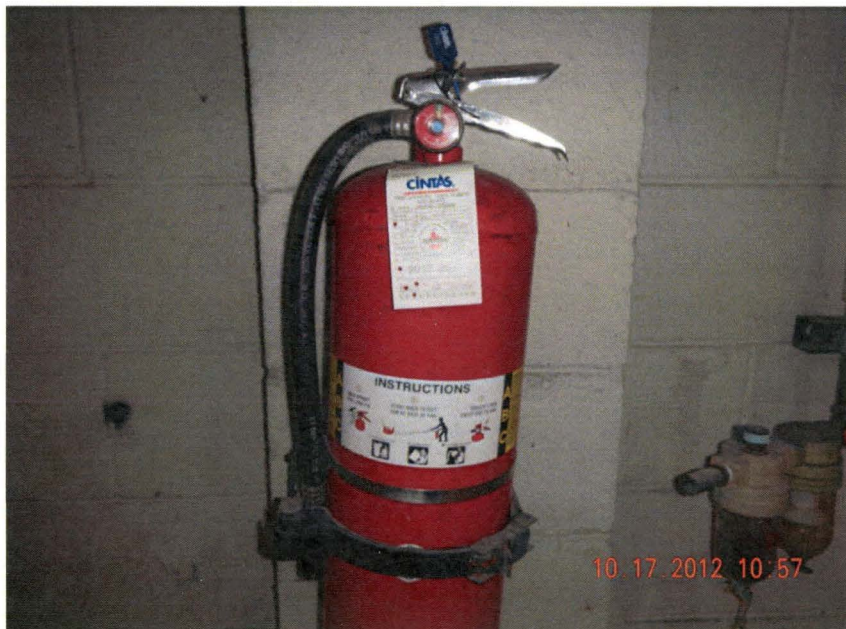
Photo 5

Photo of one fire extinguisher (2 of 3 with no marked inspection date) located at Building I. Photo taken facing south.

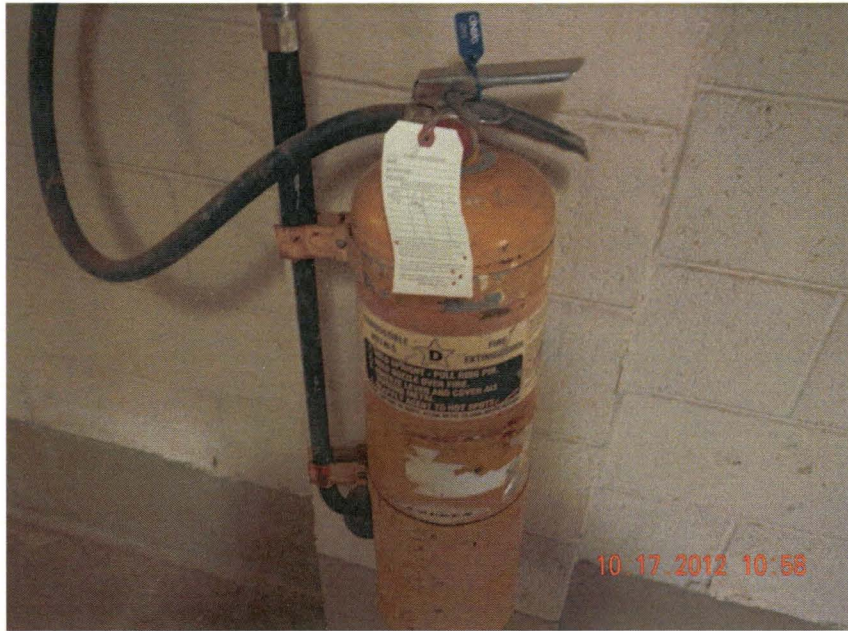
Photo 7

Photo of one fire extinguisher (3 of 4 with the April 30, 2012 last inspection date) located at Building I. Photo taken facing south.

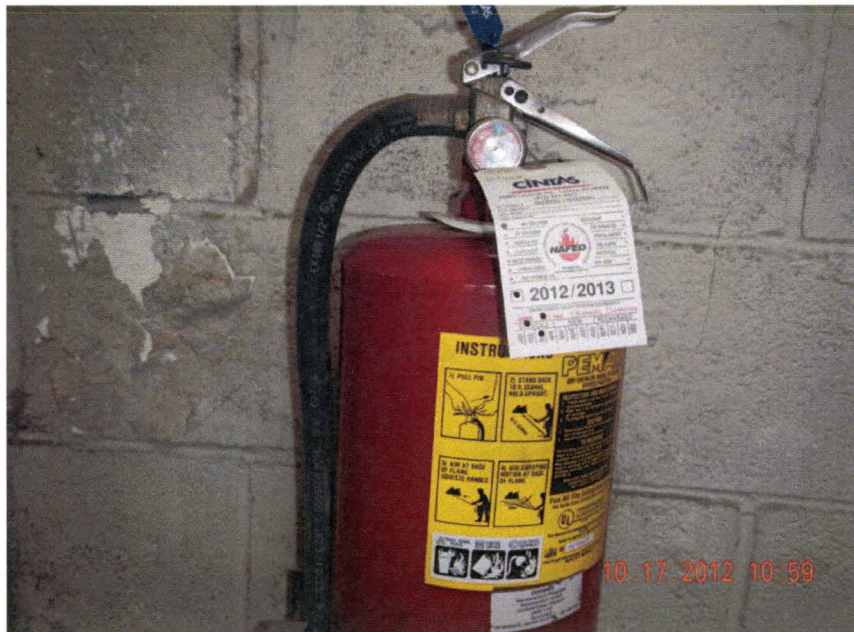
Photo 8

Photo of one fire extinguisher (3 of 3 with no marked inspection date) located at Building I. Photo taken facing south.

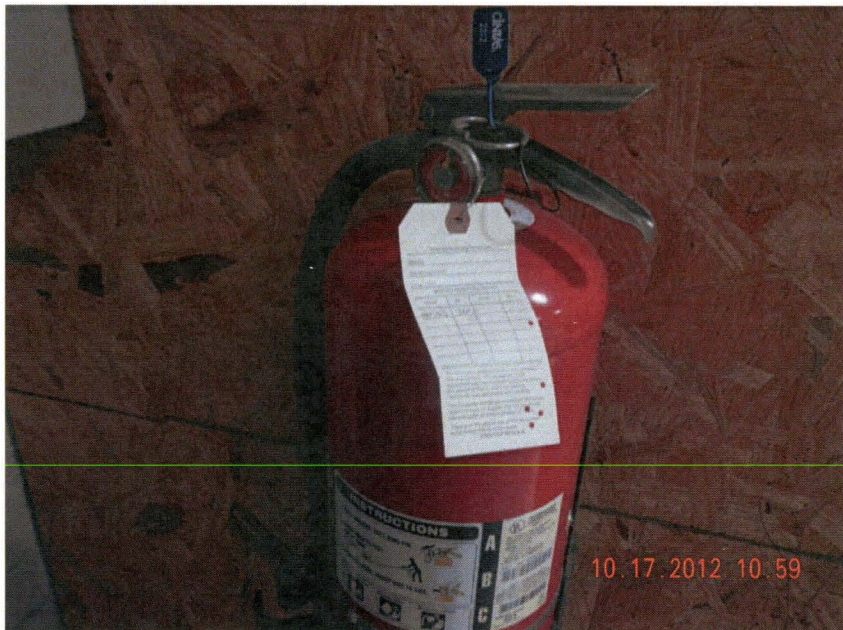
Photo 10

Photo of one fire extinguisher (4 of 4 with the April 30, 2012 inspection date) located at Building I. Photo taken facing south.

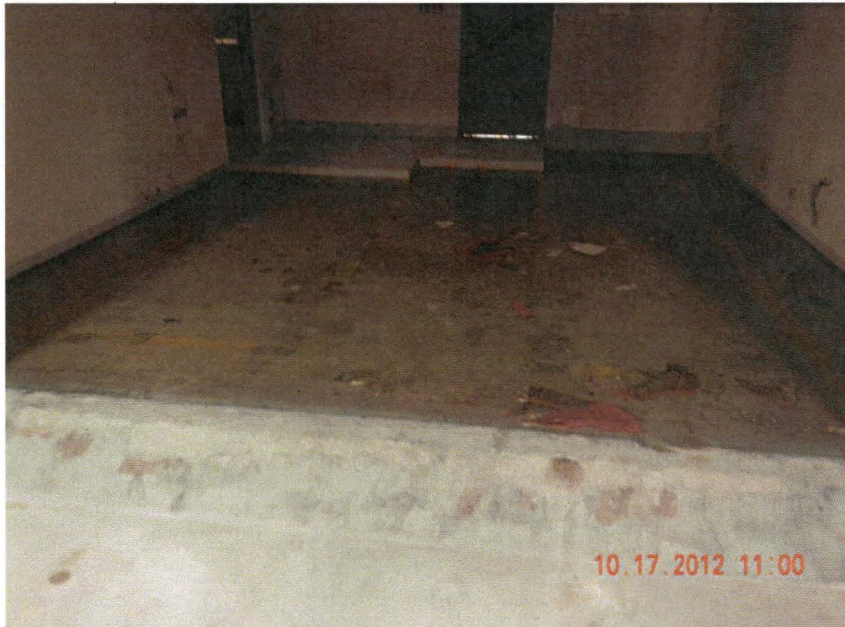
Photo 11

Photo of accumulated precipitation in
containment system #1 located at Building
I. Photo taken facing north.

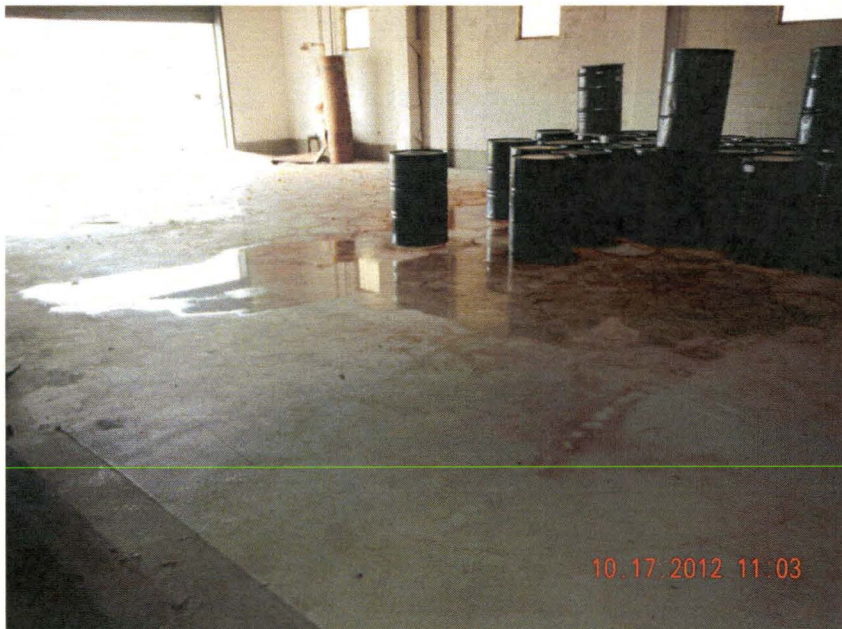
Photo 14

Photo of accumulated precipitation in
containment system #2 located at Building
I. Photo taken facing northwest.

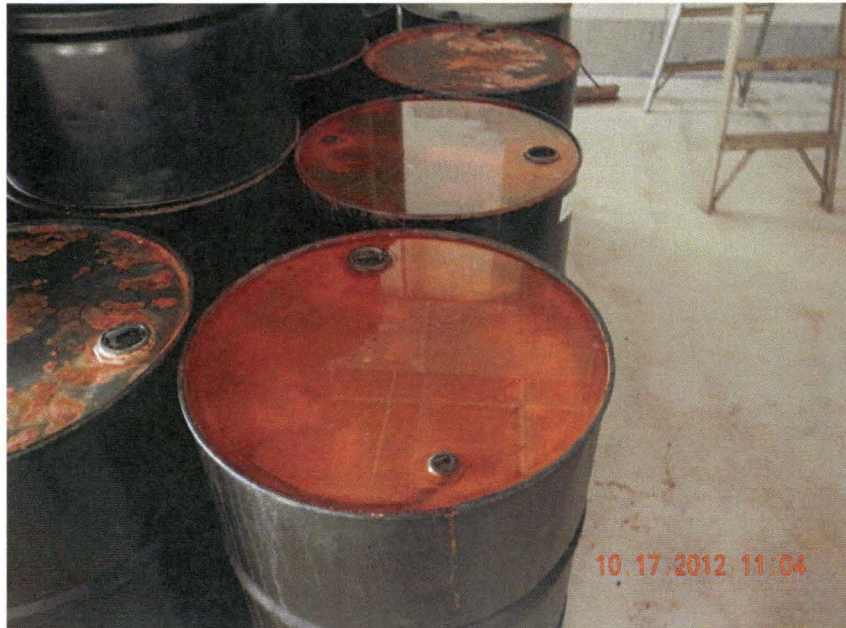
Photo 15

Photo of accumulated precipitation on empty 55 gallon containers located in containment system #2 located at Building I. Photo taken facing west.

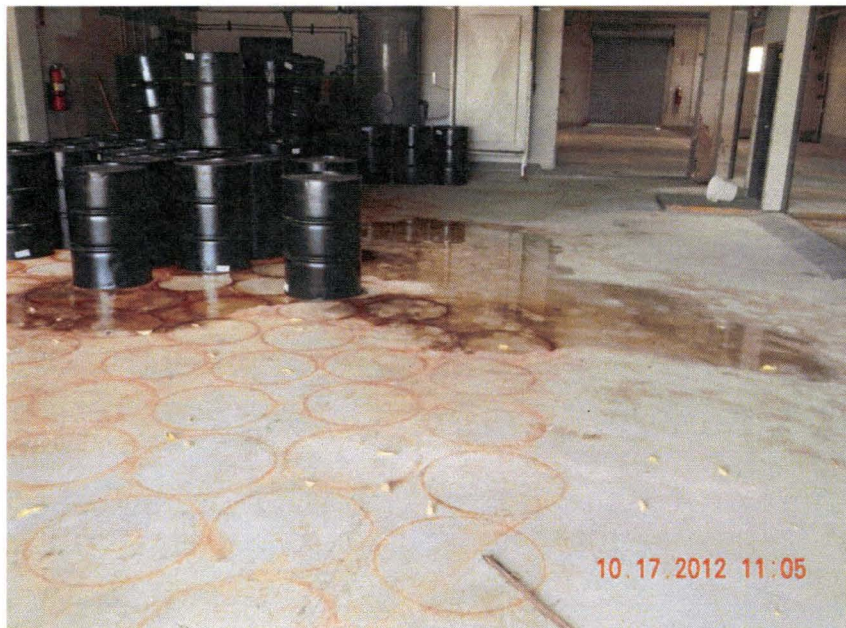
Photo 16

Photo of accumulated precipitation in containment system #2 located at Building I. Photo taken facing north.

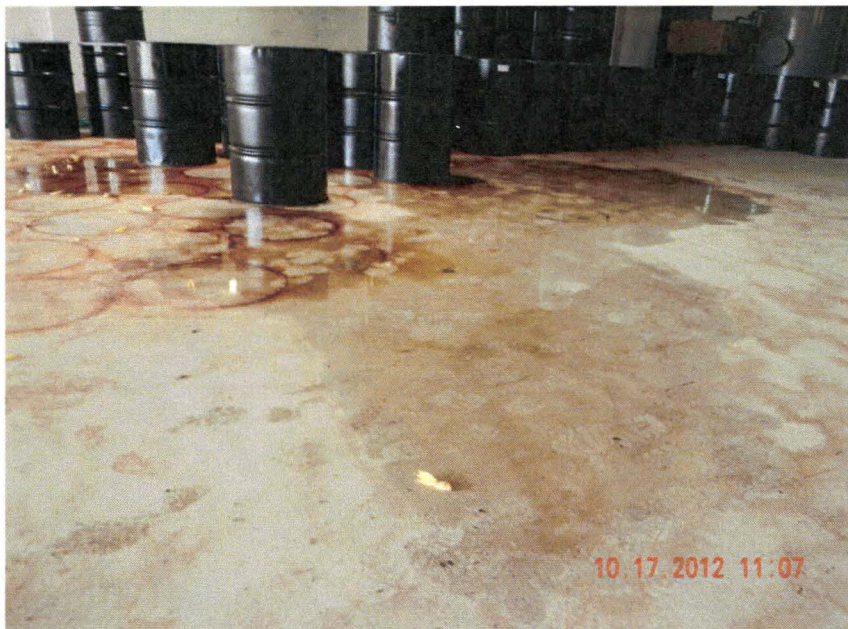
Photo 19

Photo of accumulated precipitation in containment system #2 located at Building I. Photo taken facing north.

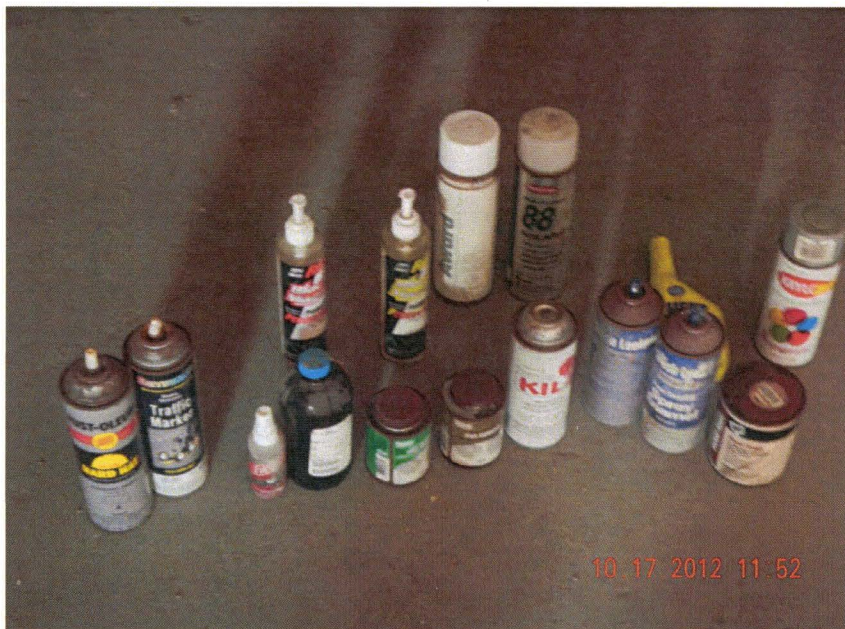
Photo 21

Photo of 15 containers of various chemicals located on the concrete floor at the Building D Maintenance Garage. Photo taken facing northwest.

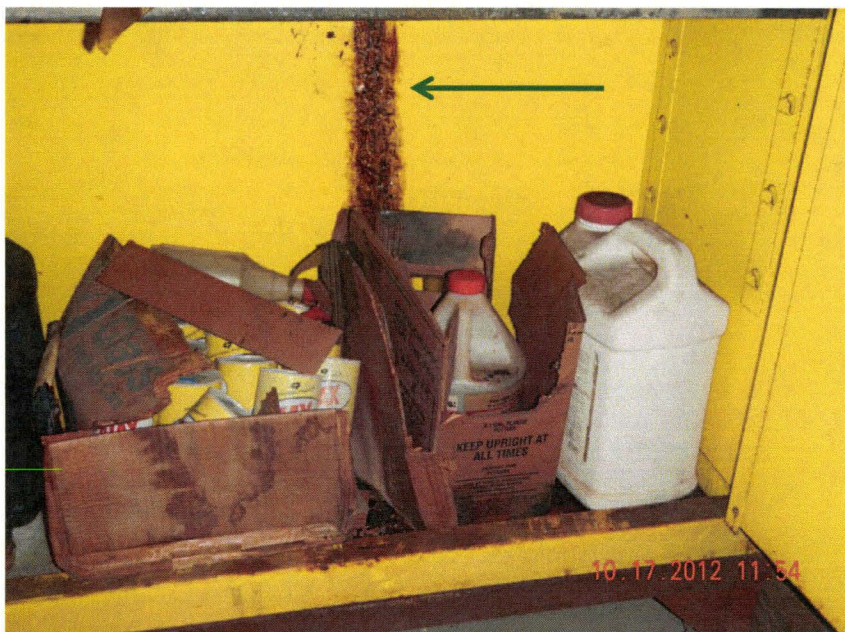
Photo 22

Photo of unknown black spilled liquid located in the flammable cabinet at the Building D Maintenance Garage. Photo taken facing north.

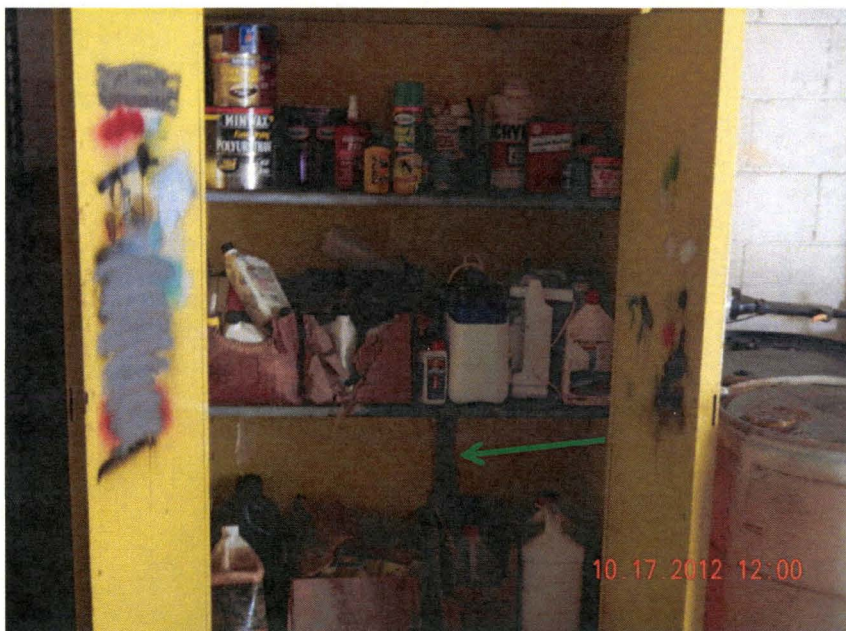
Photo 25

Photo of one flammable cabinet
(50 containers of various chemical and an
unknown black spilled liquid) located at
the Building D Maintenance Garage.
Photo taken facing north.

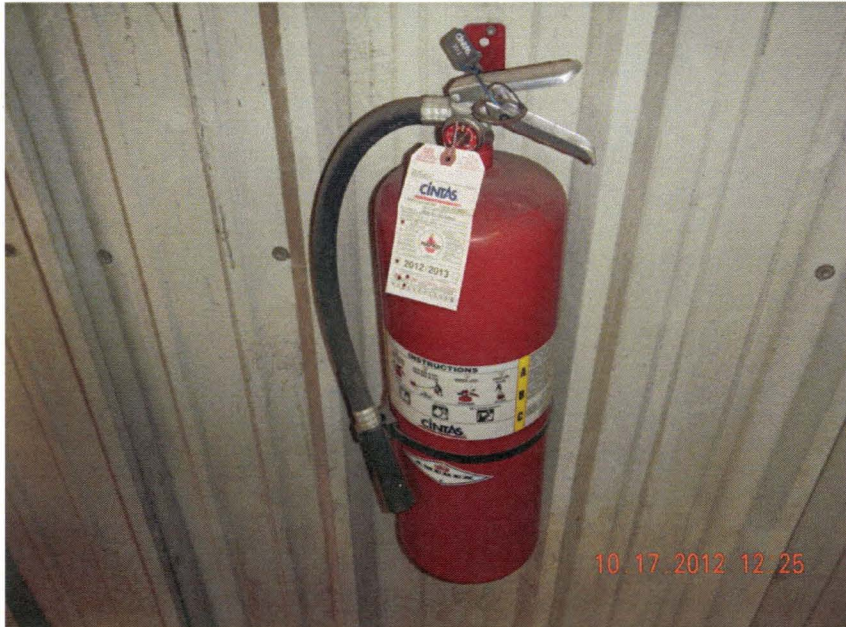
Photo 39

Photo of one fire extinguisher (1 of 2 with no marked inspection date) located at Building C. Photo taken facing south.

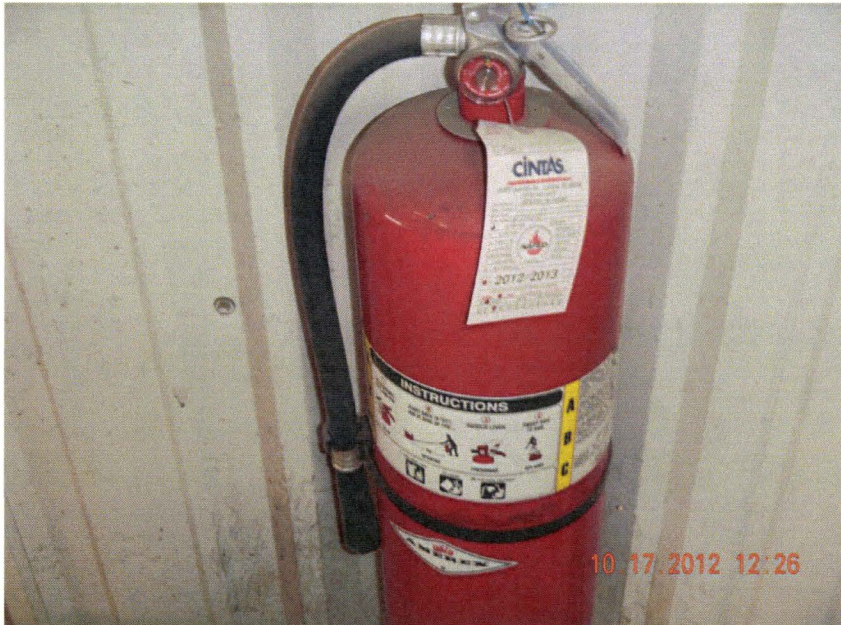
Photo 41

Photo of one fire extinguisher (2 of 2 with no marked inspection date) located at Building C. Photo taken facing south.

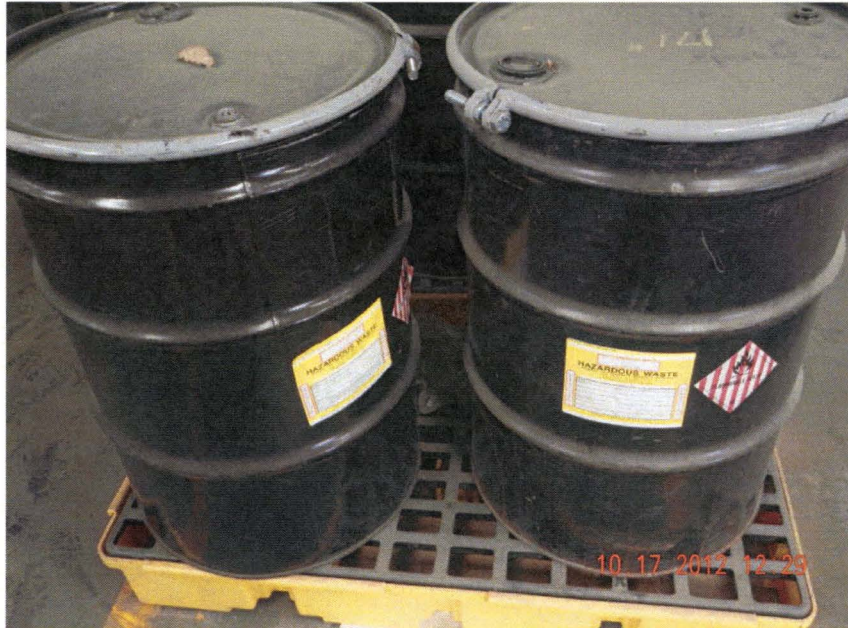
Photo 43

Photo of two 55 gallon containers of spent PPE (no marked accumulation start date) located at Building C. Photo taken facing east.

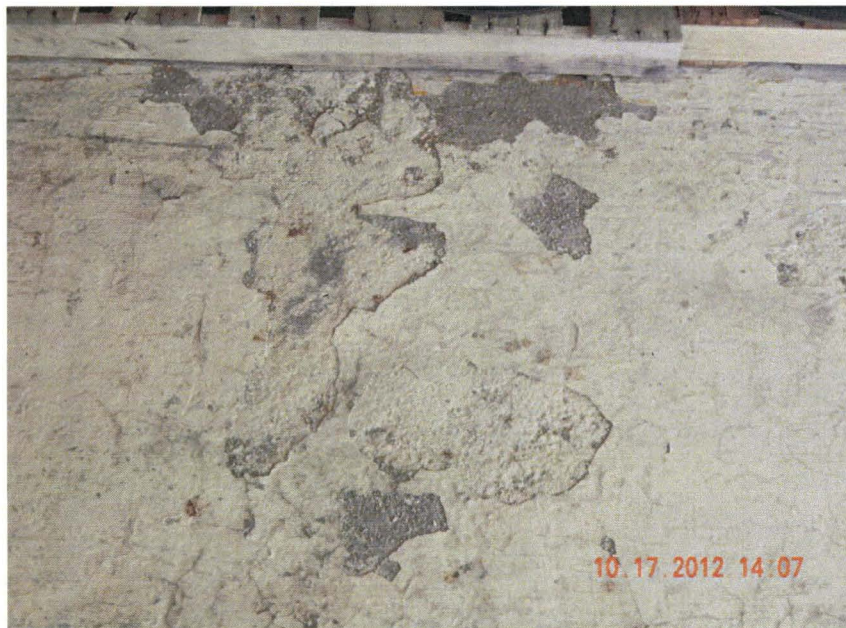
Photo 49

Photo of the Dock Area containment system (coating missing in some areas).
Photo taken facing east.

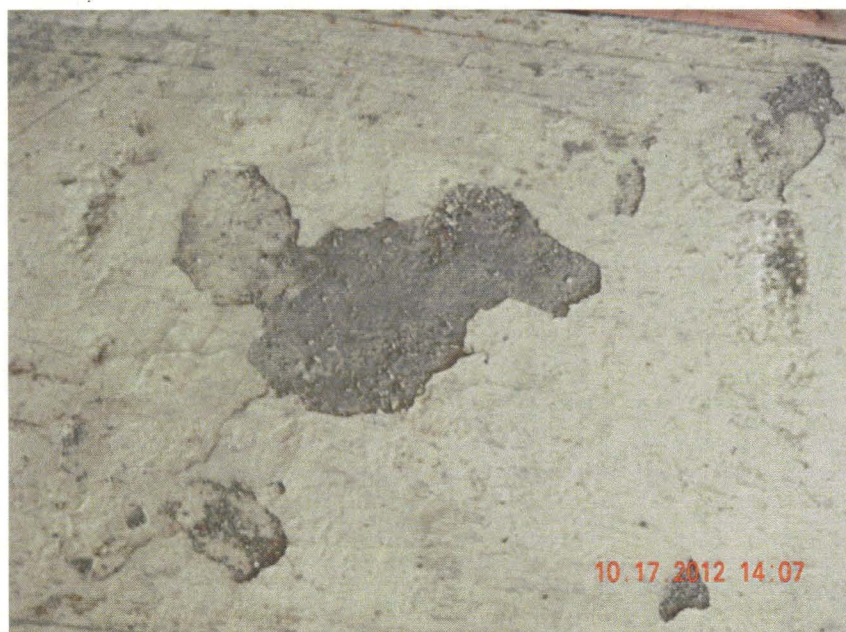
Photo 50

Photo of the Dock Area containment system (coating missing in some areas).
Photo taken facing east.

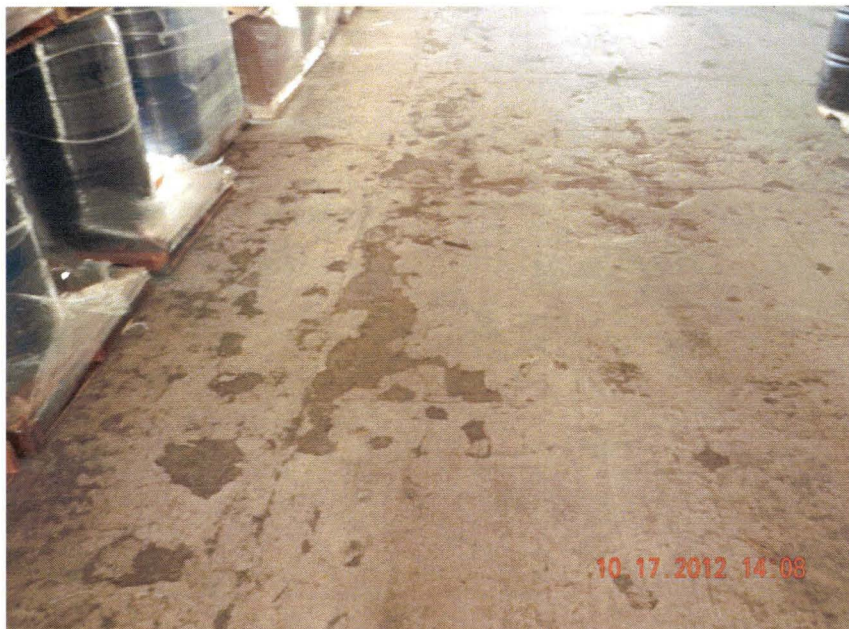
Photo 51

Photo of the Dock Area containment system (coating missing in some areas).
Photo taken facing east.

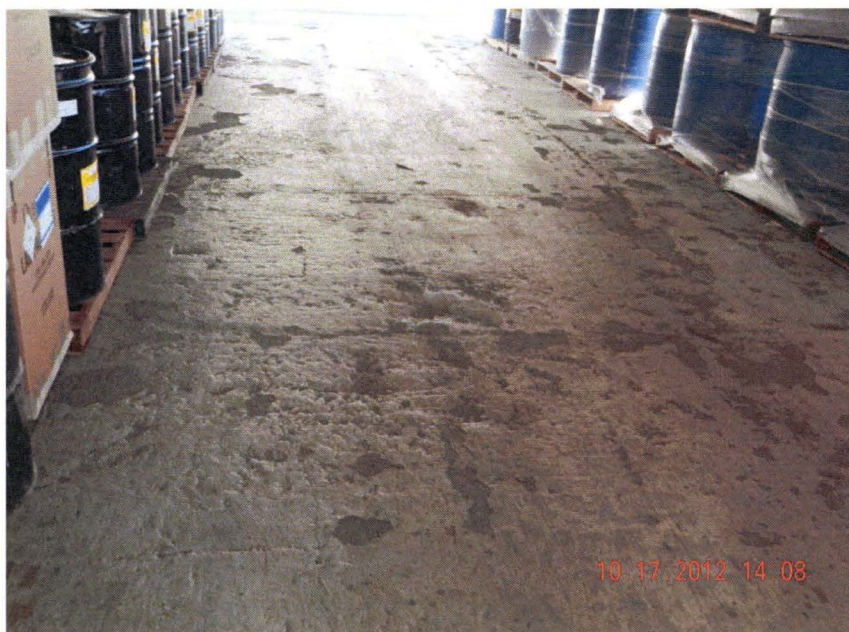
Photo 52

Photo of the Dock Area containment system (coating missing in some areas).
Photo taken facing east.

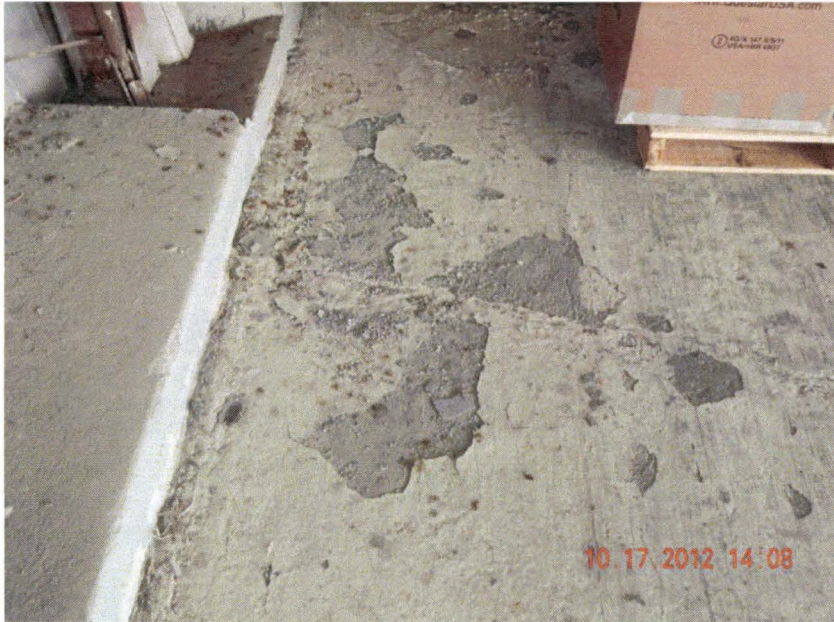
Photo 53

Photo of the Dock Area containment system (coating missing in some areas).
Photo taken facing east.

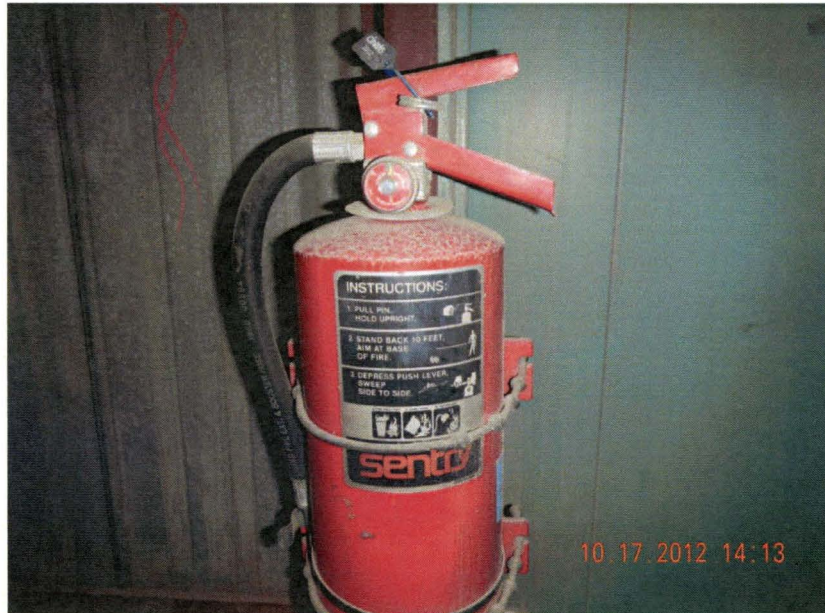
Photo 54

Photo of one fire extinguisher (no inspection tag) located at Building C.
Photo taken facing south.

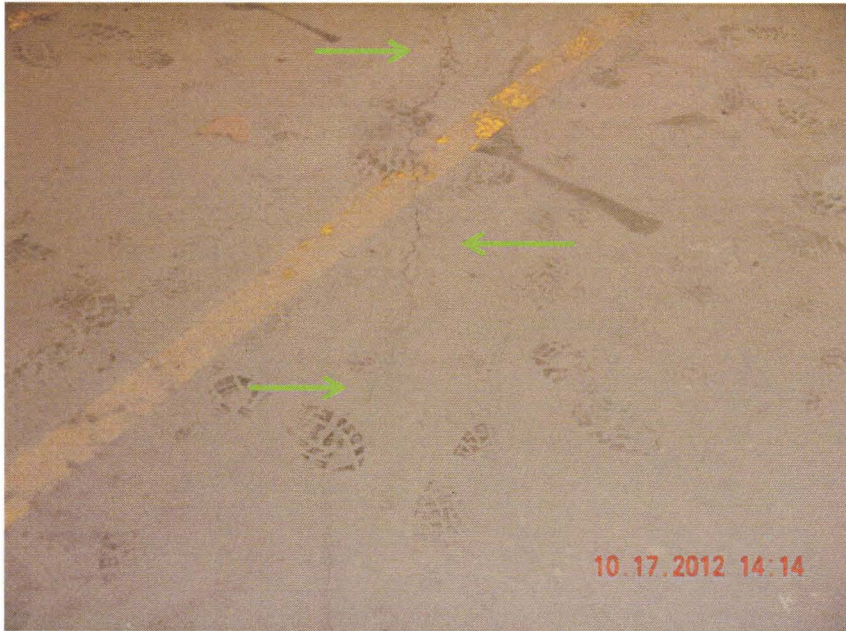
Photo 55

Photo of the cracks in the containment system at Building C. Photo taken facing east.

NOV 54 Bldg Hair crack in corner 24 foot end of study
55 long
56
57 Split in caulking 20ft long
58 Crack joint
-62 Same

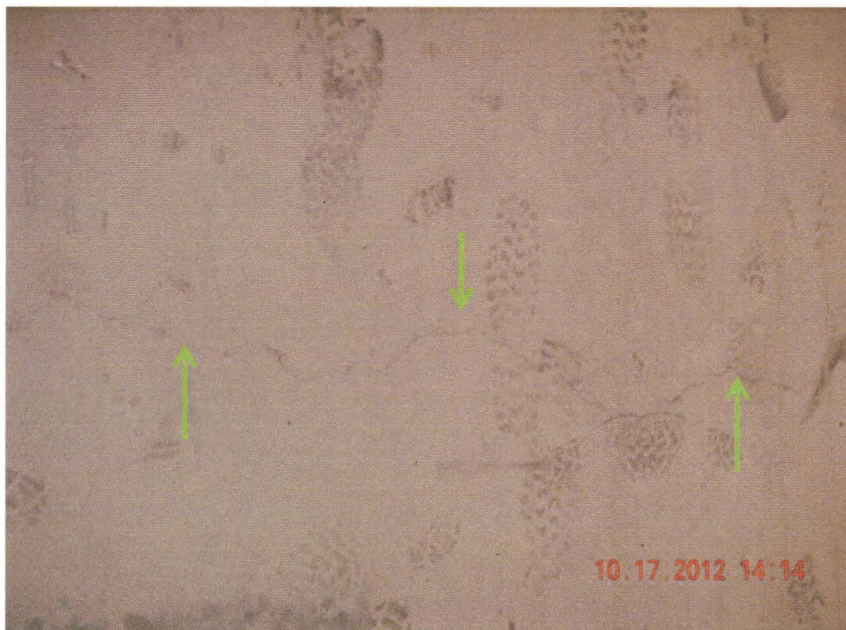
Photo 56

Photo of the cracks in the containment system at Building C. Photo taken facing east.

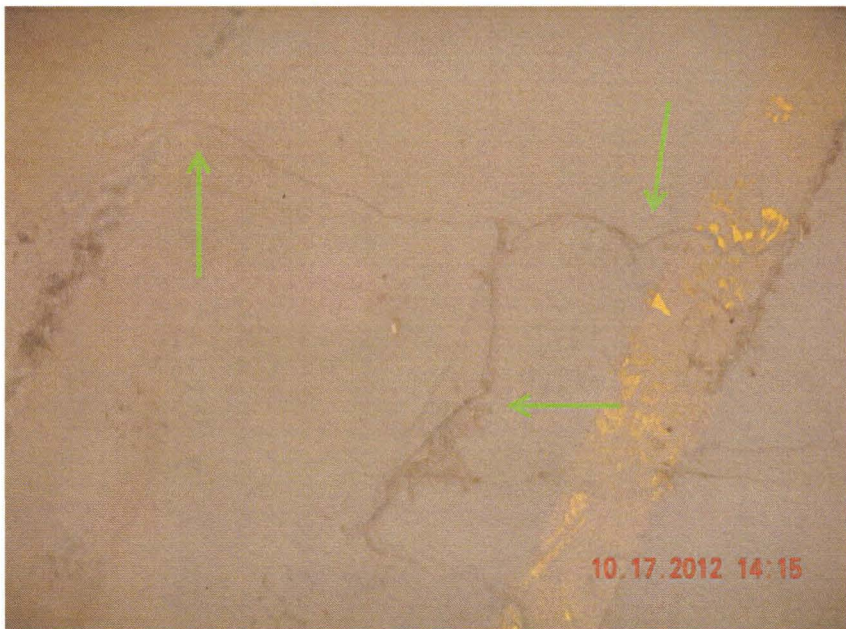
Photo 57

Photo of the cracks in the containment system at Building C. Photo taken facing east.

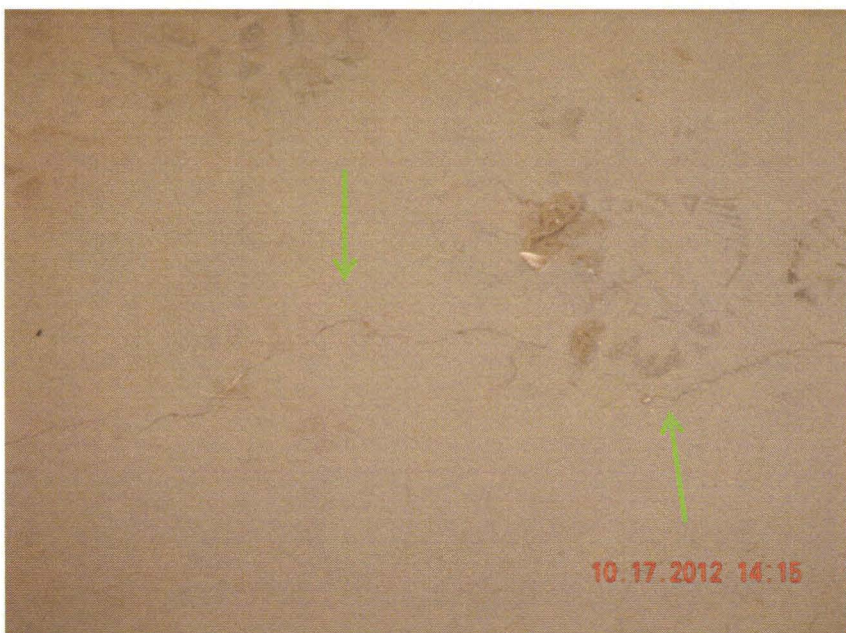
Photo 58

Photo of the cracks in the containment system at Building C. Photo taken facing east.

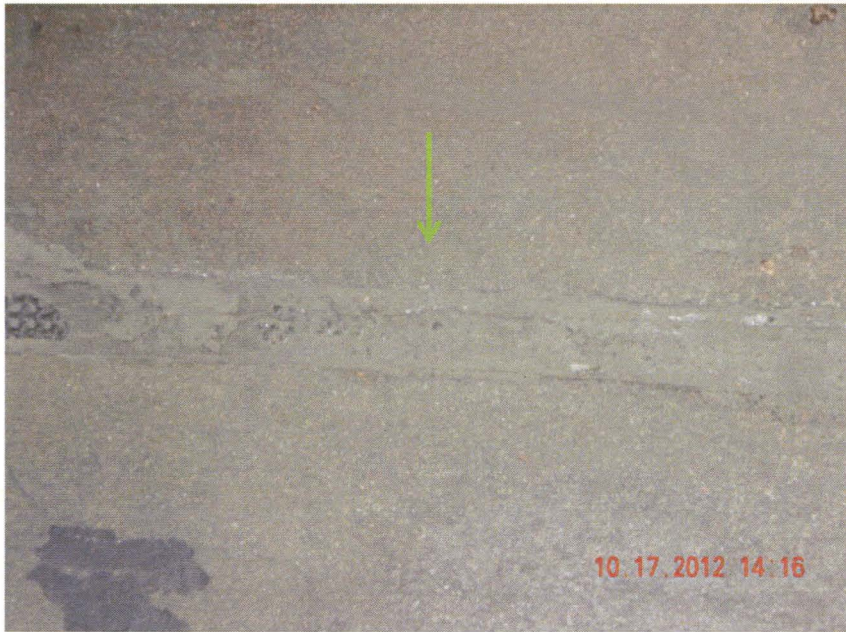
Photo 59

Photo of the caulking material located on
the containment system at Building C.
Photo taken facing west.

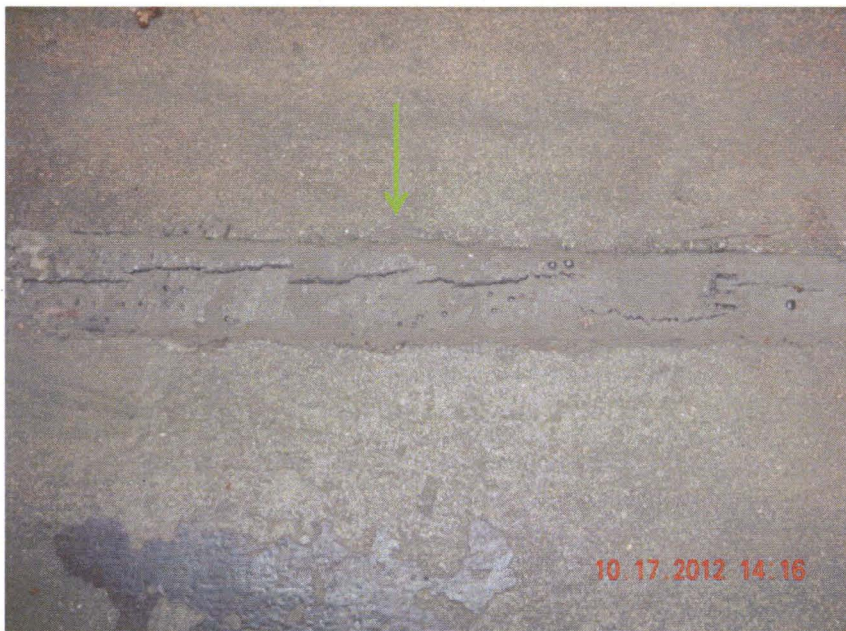
Photo 60

Photo of the caulking material located on
the containment system at Building C.
Photo taken facing west.

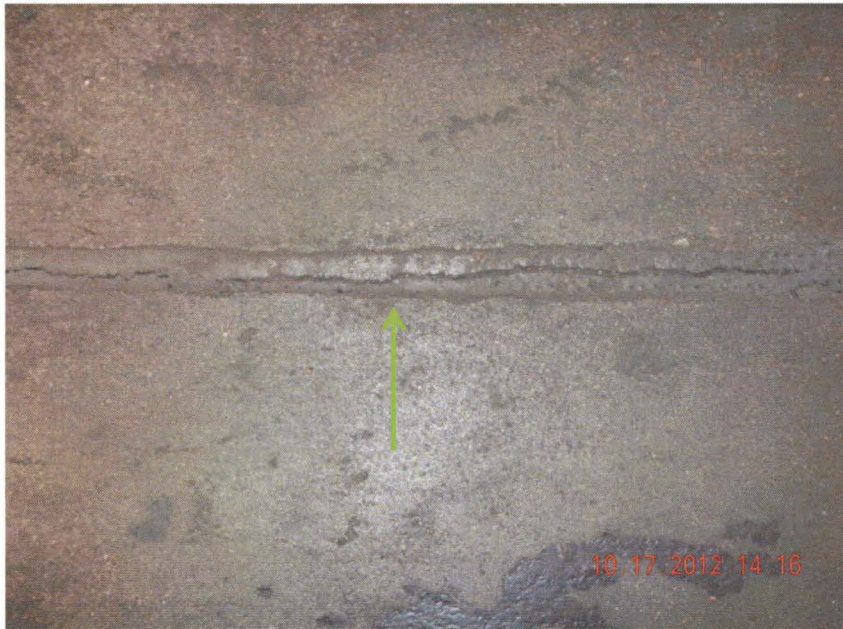
Photo 61

Photo of the caulking material located on
the containment system at Building C.
Photo taken facing west.

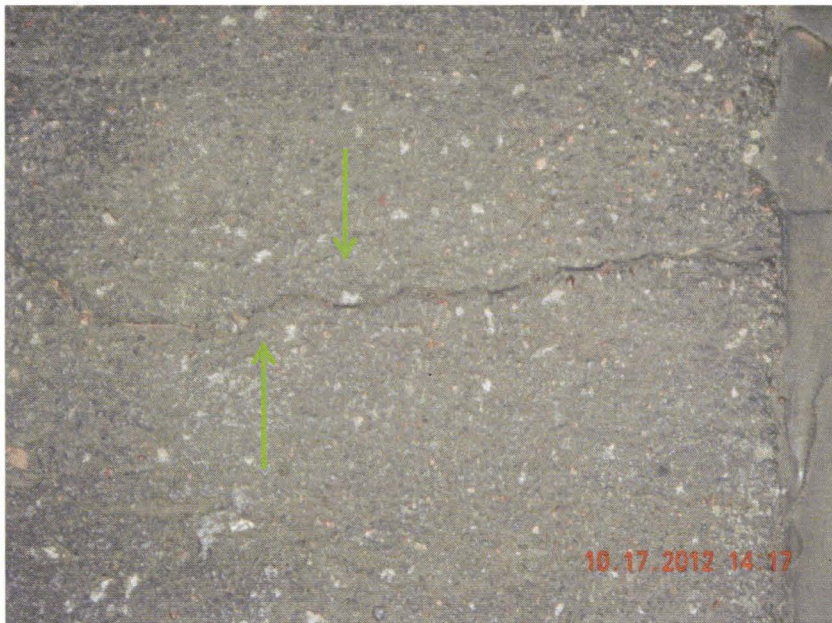
Photo 62

Photo of cracks in the containment system
at Building C. Photo taken facing west.

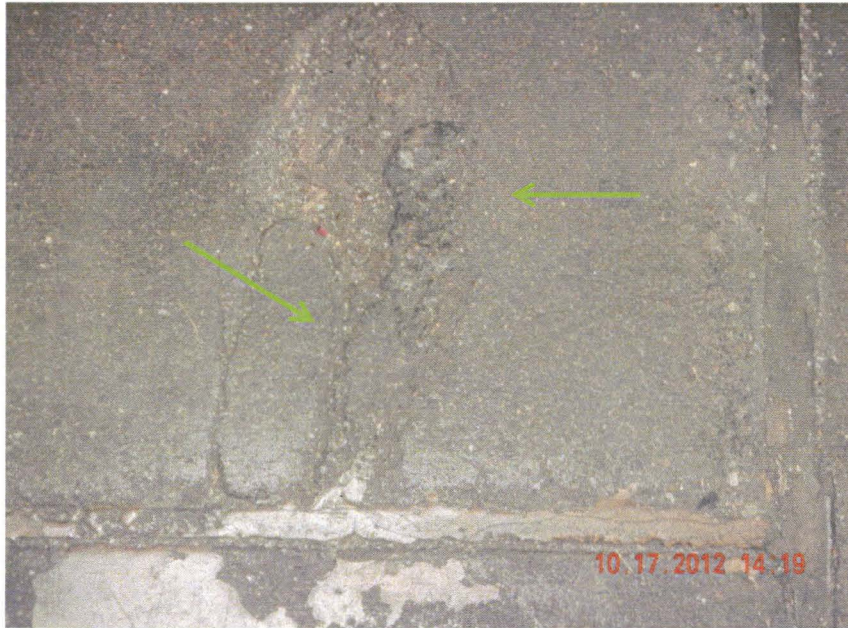
Photo 63

Photo of gaps in the concrete of the
containment system at Building C.
Photo taken facing west.
